PHOTOGRAPHIC INTELLIGENCE REPORT

I-HSIEN MILITARY COMPLEX

CHINA

CIA/PIR 77019

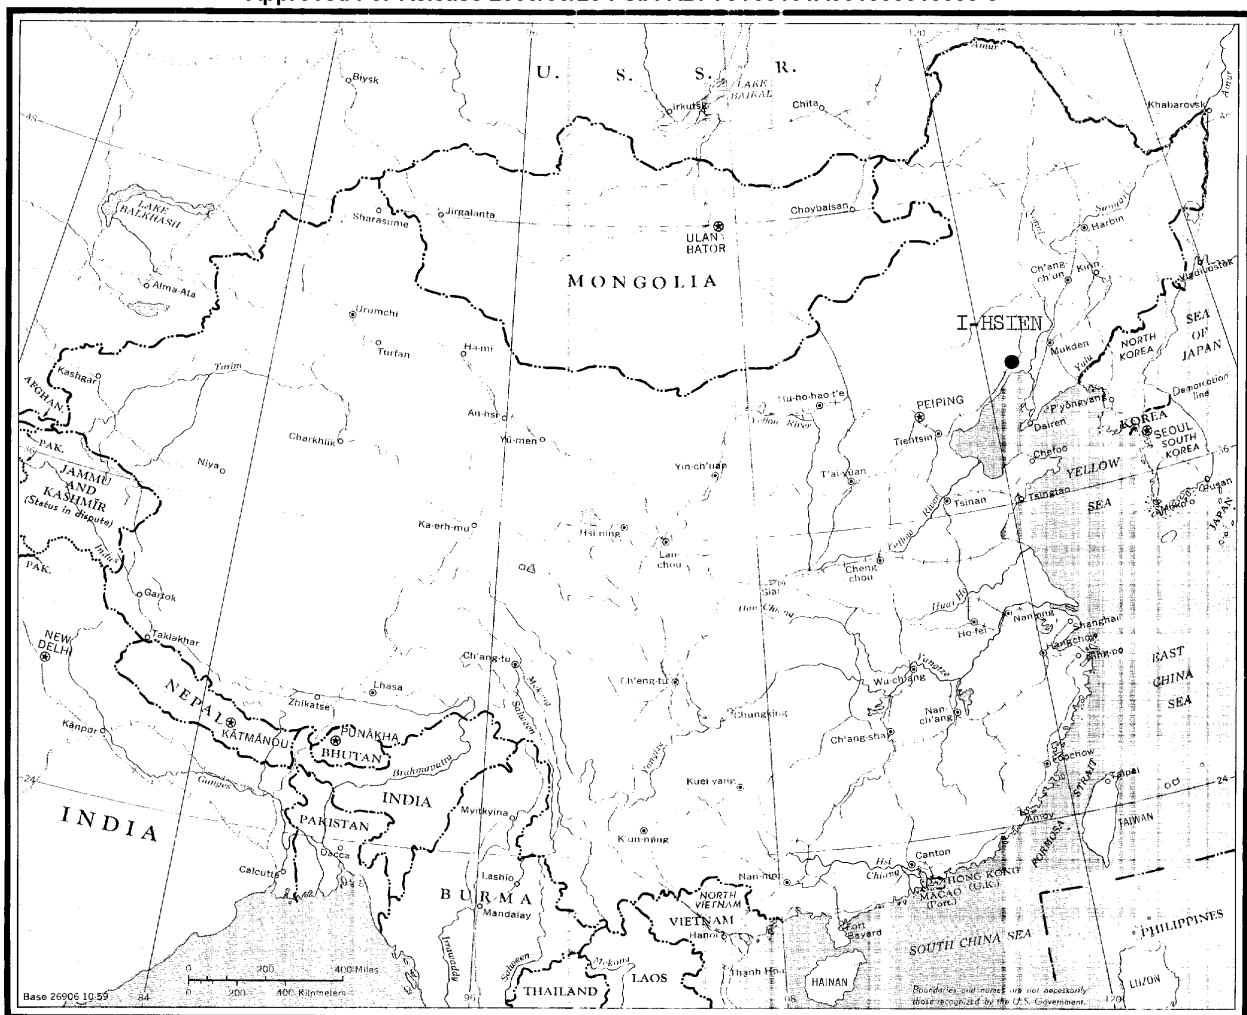
Figure 2

1. Headquarters and Support Elements
2. Probable Infantry Regiment A
3. Probable Artillery Regiment
4. Probable Infantry Regiment B
5. Probable Infantry Regiment C

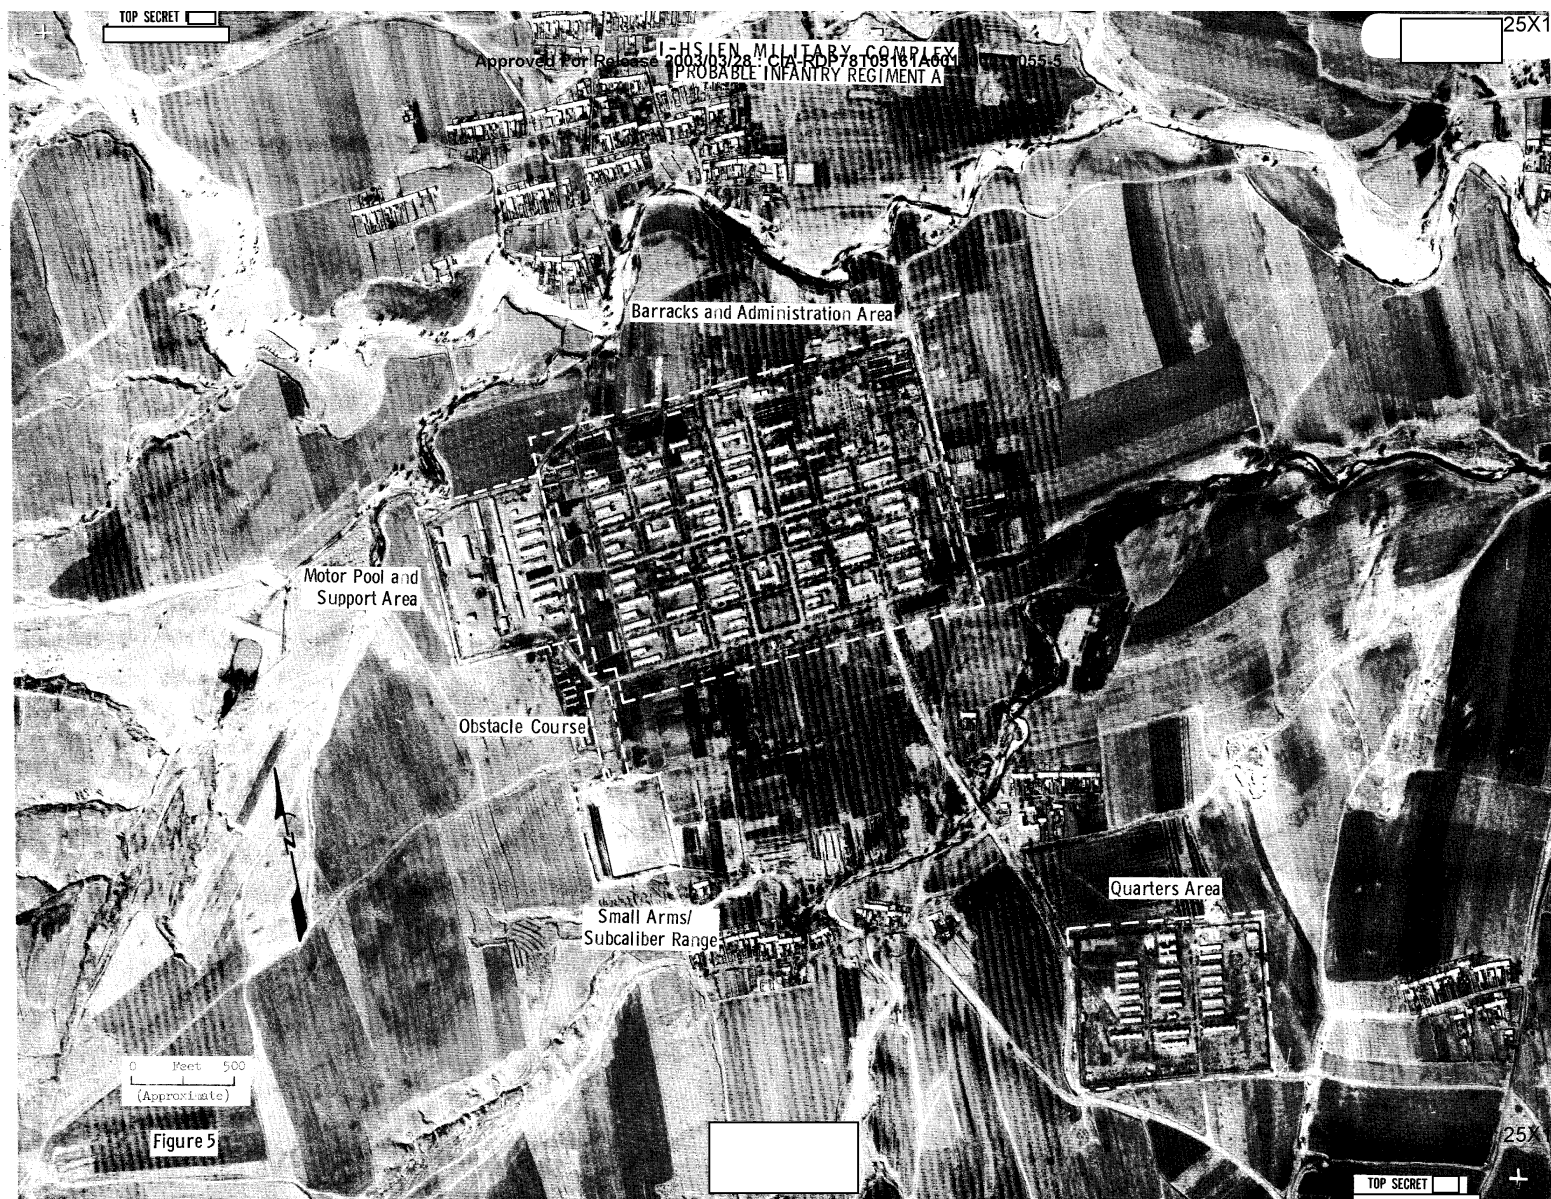
Figure 5

PROBABLE INFANTRY REGIMENT A
FIGURE 5

Barracks and Administration Area

- 1 H-shaped administration building
- 4 C-shaped administration buildings
- 41 Barracks
- 12 Probable quarters
- 1 T-shaped auditorium/gymnasium
- 4 Messhalls
- 1 Heat/power plant
- 55 Support buildings

Motor Pool and Support Areas

- 2 Probable vehicle sheds
- 2 Small vehicle maintenance buildings
- 12 Probable storage buildings
- 10 Support buildings
- 3 Vehicle maintenance ramps

Quarters Area

- 1 Probable administration building
- 18 Probable quarters
- 1 Probable messhall
- 8 Support buildings

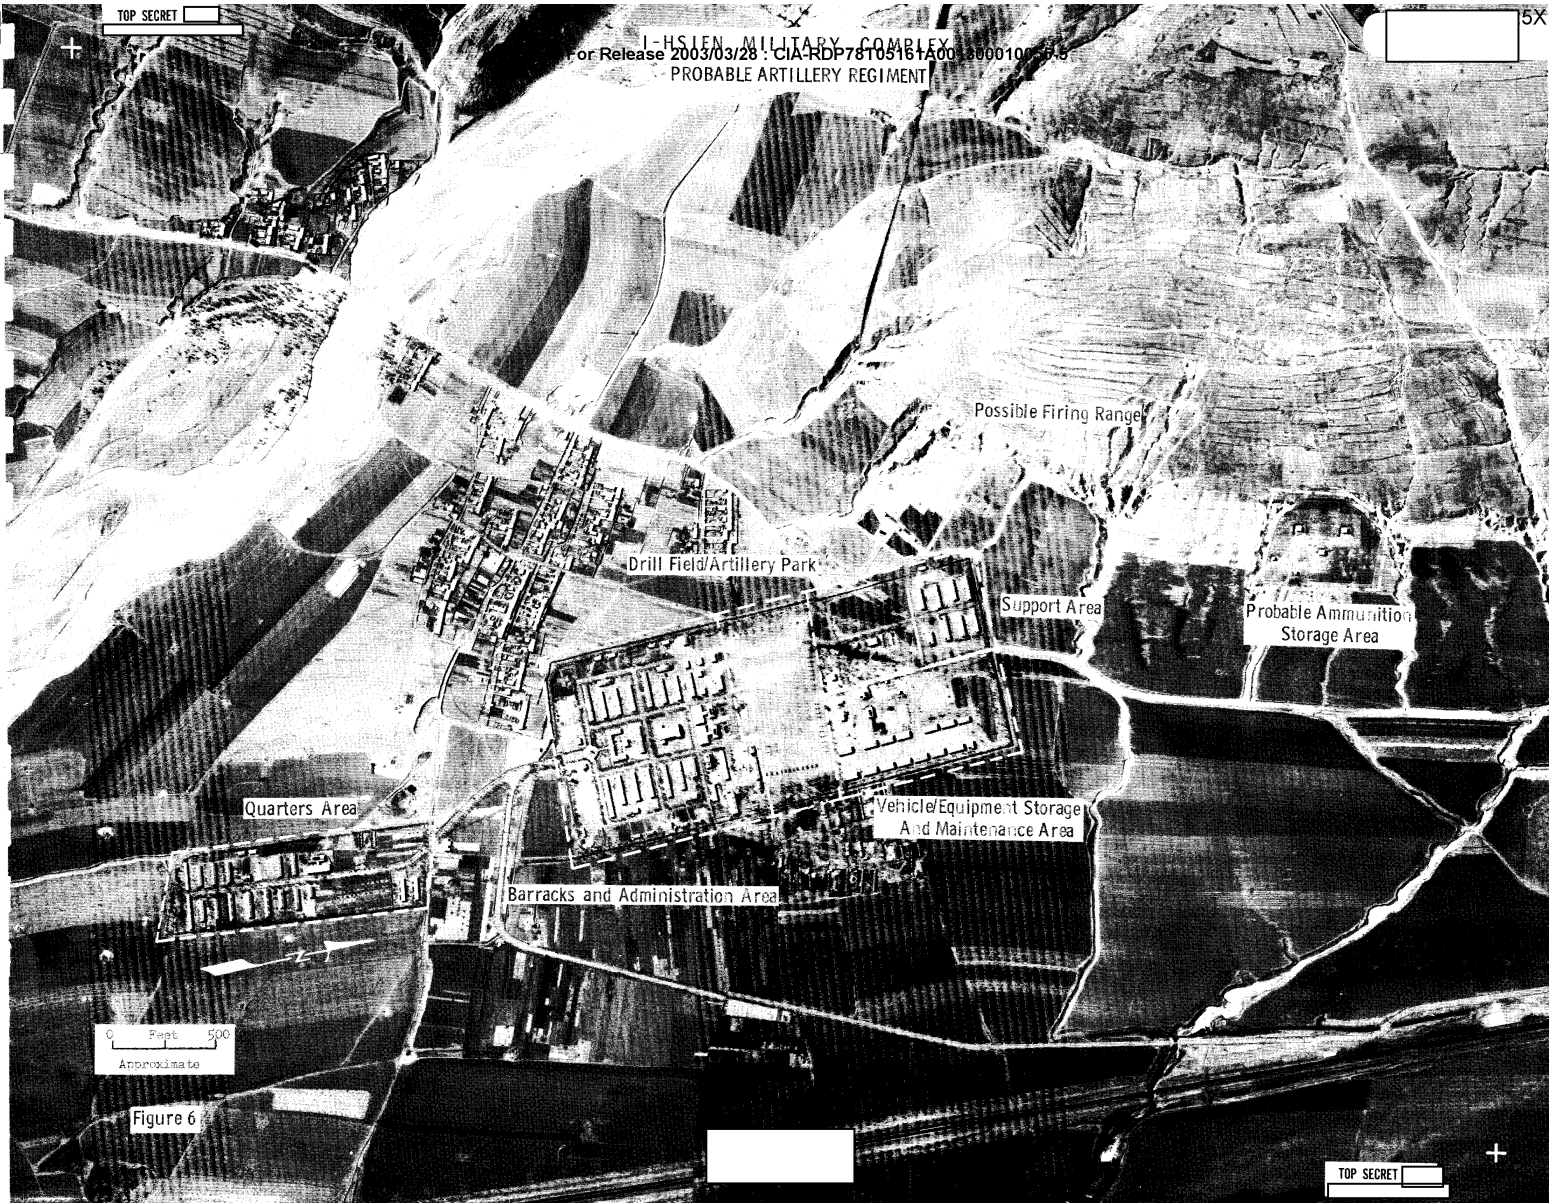
PROBABLE ARTILLERY REGIMENT
FIGURE 6

Barracks and Administration Area

- 1 C-shaped administration building
- 15 Barracks
- 1 T-shaped auditorium/gymnasium
- 2 Messhalls
- 34 Support buildings
- 1 Probable water tower

Vehicle/Equipment Storage and Maintenance Area

- 14 Probable vehicle/equipment sheds
- 2 Vehicle maintenance buildings
- 7 Support buildings
- 2 Vehicle maintenance ramps

Five cargo trucks are located in this area.

Drill Field/Artillery Park

Eighteen probable 85 mm field guns, 12 probable 122/152 mm howitzers, and 12 probable 120 mm mortars are located in this area on [REDACTED] coverage.

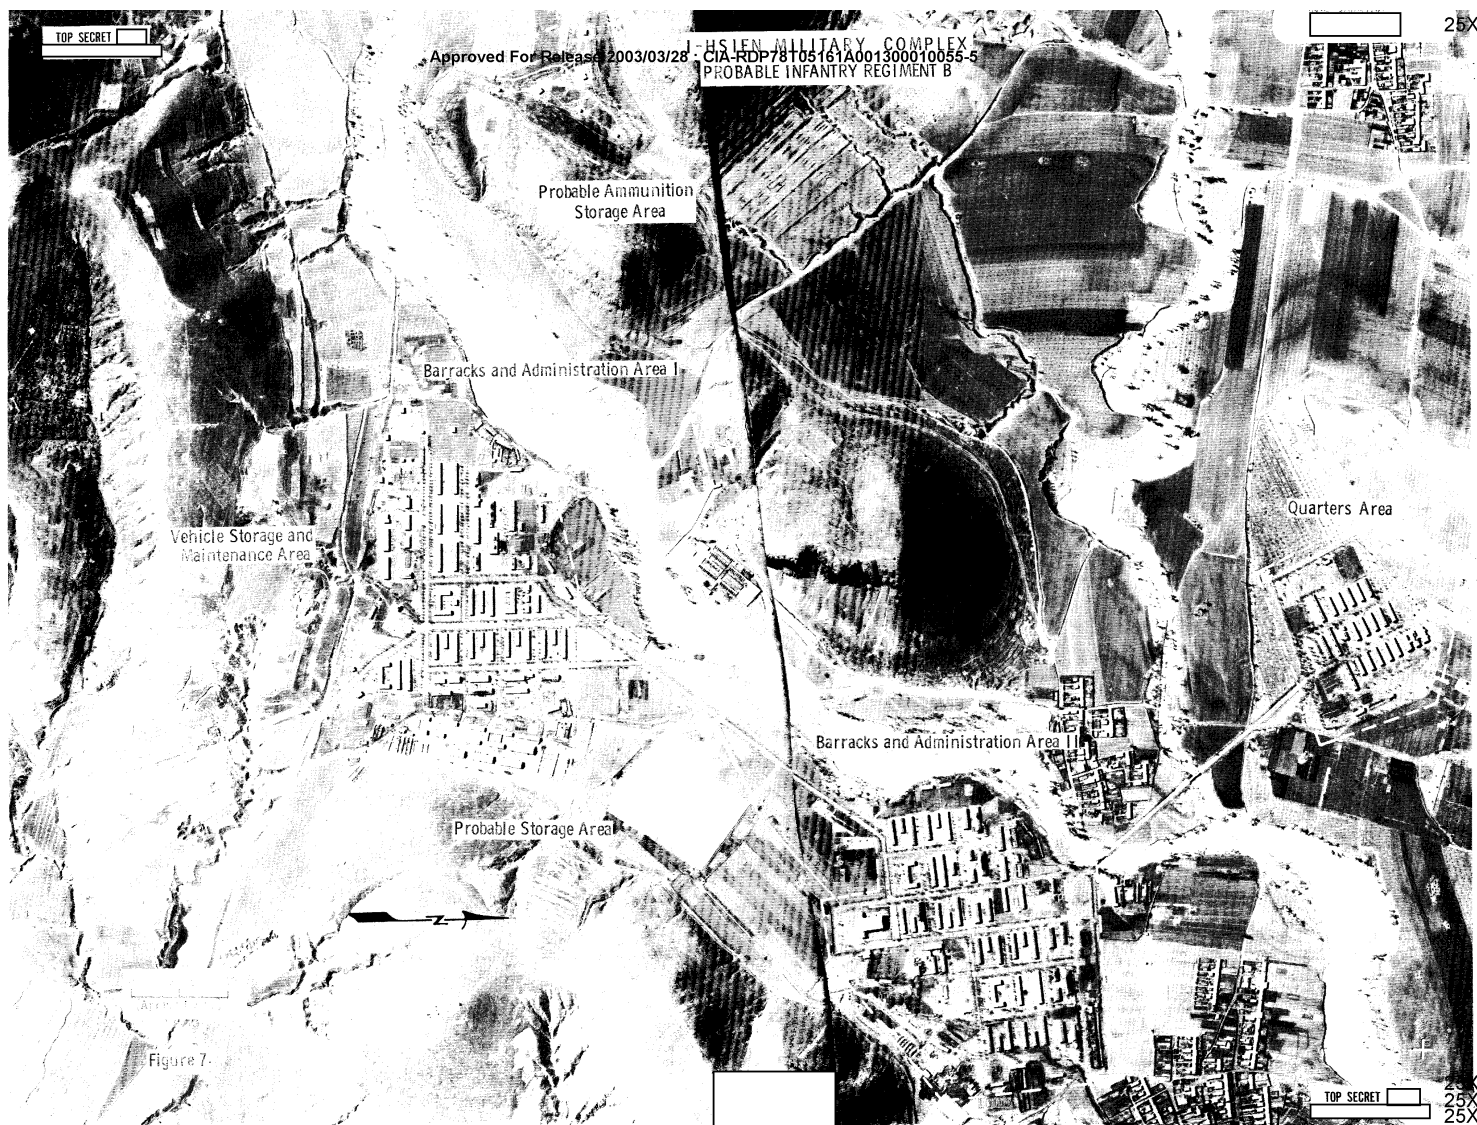
PROBABLE INFANTRY REGIMENT B
FIGURE 7Barrack and Administration Area I

- 1 H-shaped administration building
- 2 C-shaped administration buildings
- 17 Barracks
- 3 Possible quarters
- 2 Messhalls
- 1 Heat/power plant
- 37 Support buildings

Barracks and Administration Area II

- 2 C-shaped administration buildings
- 20 Barracks
- 8 Possible quarters
- 1 T-shaped auditorium/gymnasium
- 2 Messhalls
- 37 Support buildings

Vehicle Storage and Maintenance Area

- 2 Probable vehicle sheds
- 2 Possible vehicle sheds
- 2 Vehicle maintenance buildings
- 6 Support buildings
- 3 Vehicle maintenance ramps

A possible small arms/subcaliber range located between the two barracks areas does not appear active. Infantry training areas are located south and east of the installation in rough terrain.

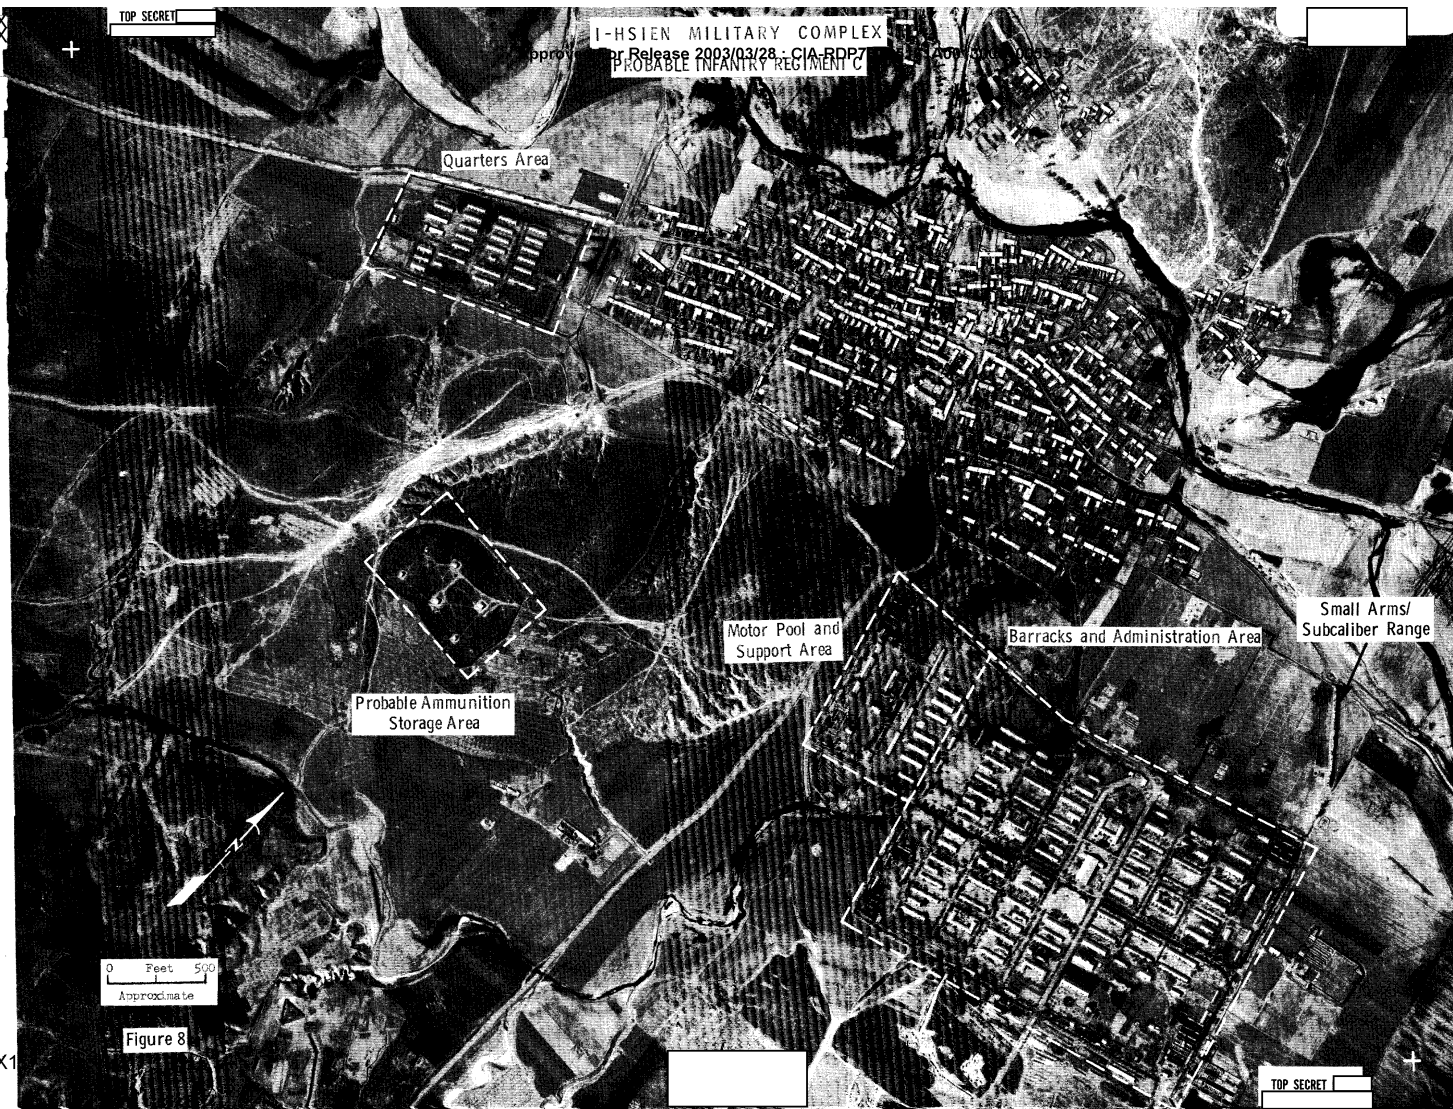
PROBABLE INFANTRY REGIMENT C
FIGURE 8Barracks and Administration Area

- 1 H-shaped administration building
- 4 C-shaped administration buildings
- 40 Barracks
- 12 Probable quarters
- 1 T-shaped auditorium/gymnasium
- 1 Heat/power plant
- 58 Support buildings

Motor Pool and Support Area

- 3 Probable vehicle sheds
- 2 Vehicle maintenance buildings
- 14 Probable storage buildings
- 13 Support buildings
- 3 Vehicle maintenance ramps

A small arms/subcaliber range located immediately north of the barracks and administration area does not appear to be in use. Infantry training facilities are located in the area southwest of this installation.
